6 September 2022

EPBC approval number: EPBC 2017/7994
Project Name: Lockyer Power Project

Annual Compliance Inspection of Lockyer Power Project Site

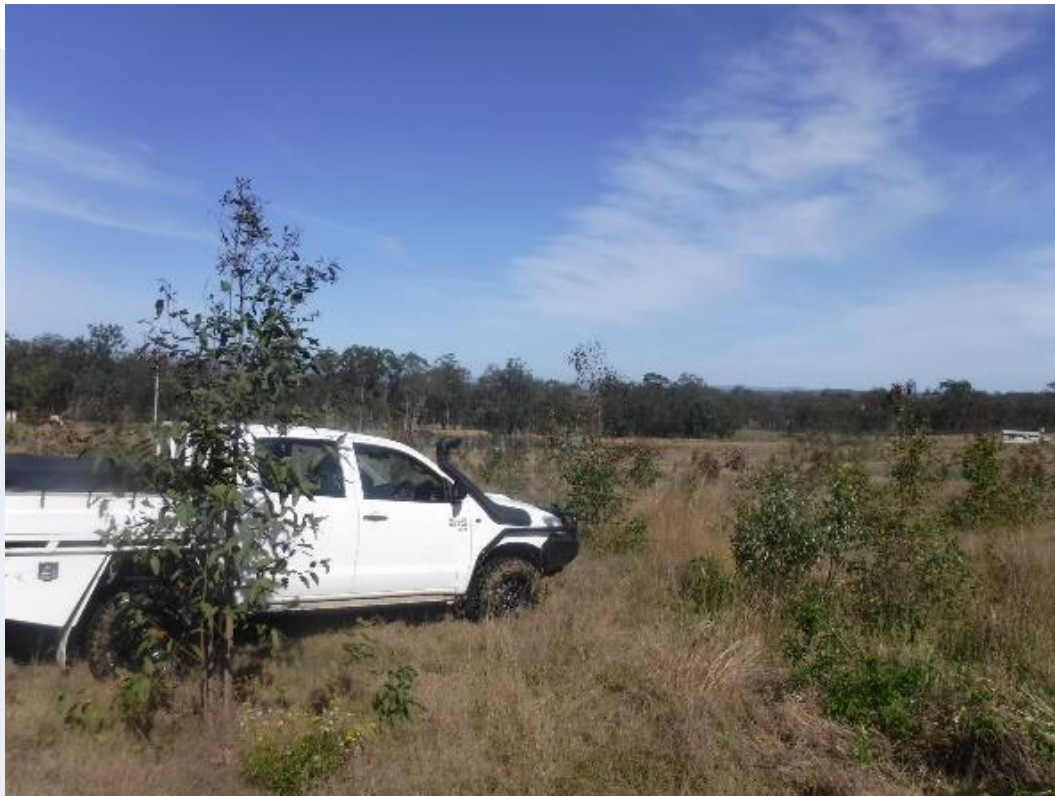
The area which was cleared of trees in September 2021 (the approved project footprint) contains a number (a few hundreds) of eucalyptus regrowth suckers, up to 4 m tall (see below photograph).

Left untreated there is a risk that this area will revegetate by itself within a short period, thereby requiring repetition of some of the approved clearing work that was performed in 2021. I inspected the area with Graeme Jenkins of Leading Rural Traders on the 6th of September, and he is available and willing to treat all those suckers by hand-spray application of a suitable herbicide within September 2022 if required. Graeme advised me that he must use hand-spray techniques as the presence of a large number of felled tree trunks across the area precludes the use of a truck-mounted boom spray.

I recommend that we obtain a quotation from Leading Rural Traders to treat the eucalyptus regrowth suckers with a suitable herbicide, then commission the work, so that it may be completed within September 2022 and referenced in the compliance report.

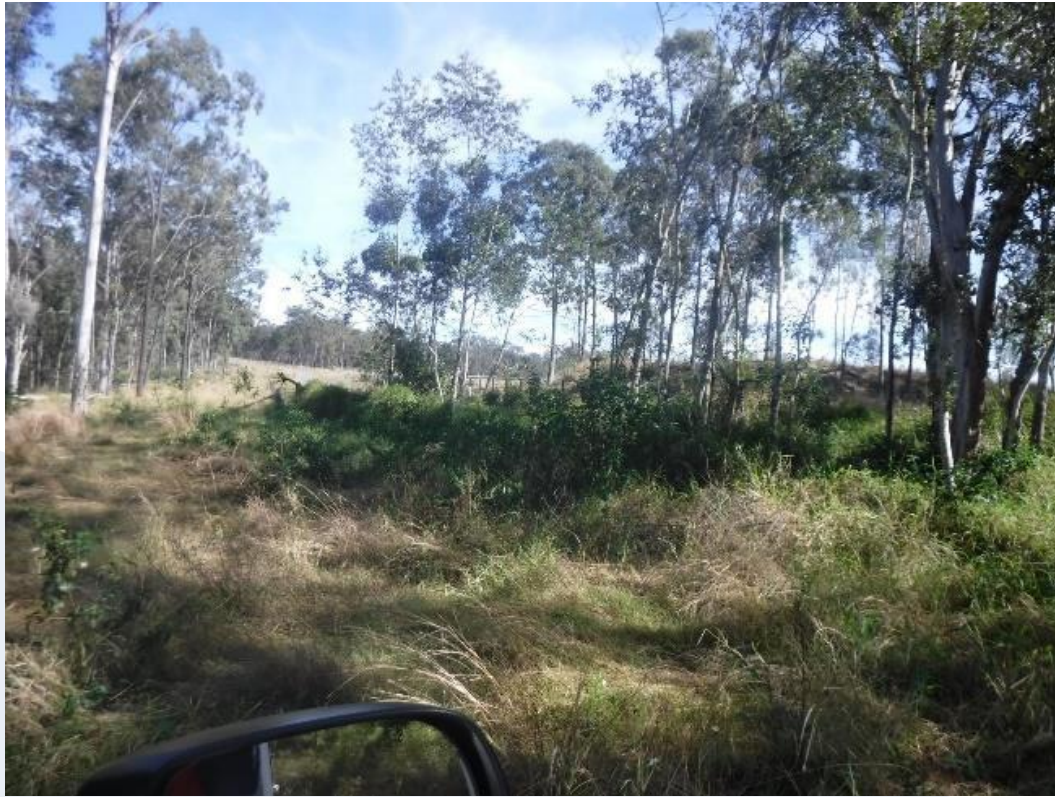
The north-western margin of Offset Area A, and an area in the fence maintenance line in the north-west corner of the lot, plus an area in the margin of Offset Area B, contains some mature Lantana (*Lantana camara*) plants and some instances of regrowth. (see below photograph).

This is one of the 20 Weeds of National Significance (WoNS) in Australia and should be controlled regularly. I inspected the area with Graeme Jenkins of Leading Rural Traders on the 6th of September, and he is available and willing to treat all these Lantana plants by application of a suitable herbicide within September 2022 if required. Graeme advised me that he will use hand-spray techniques within Offset Areas A and B in order to avoid damaging existing trees.

I recommend that we obtain a quotation from Leading Rural Traders to treat the Lantana plants with a suitable herbicide, then commission the work so that it may be completed within September 2022 and referenced in the compliance report.

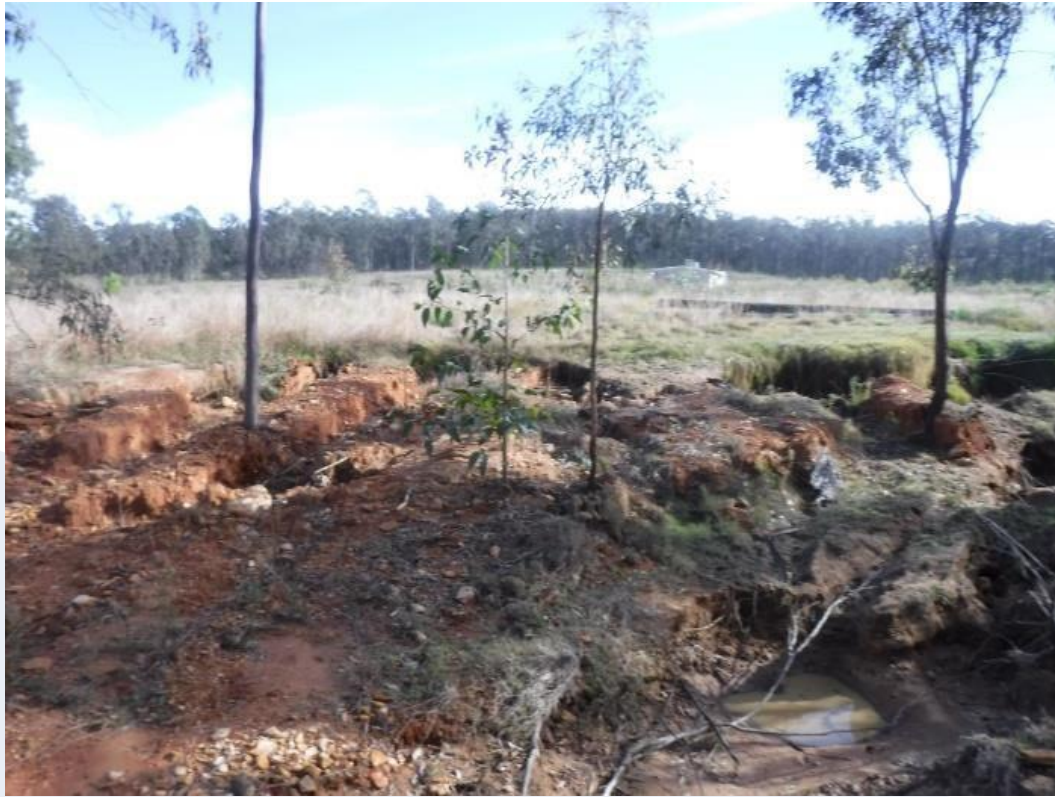
The by-wash located on the north-western and western side of the farm dam which is located in the southern end of the cleared area shows some evidence of erosion, due to recent exceptionally heavy rainfall events, and will likely require the placement of some fill and gravel cover. (see below photograph).

If left untreated, there is a risk that the dam wall may become damaged or leak, and release sediment into the drainage feature to the south-west.

I inspected the area with Graeme Jenkins of Leading Rural Traders on the 6th of September, and he is available and willing to rectify the erosion by placement of fill with an armouring top layer of suitably sized gravel.

I have requested a quotation from Leading Rural Traders to rectify the damage to the by-wash, and will submit same to you for approval shortly, so that the work may be completed as soon as possible.

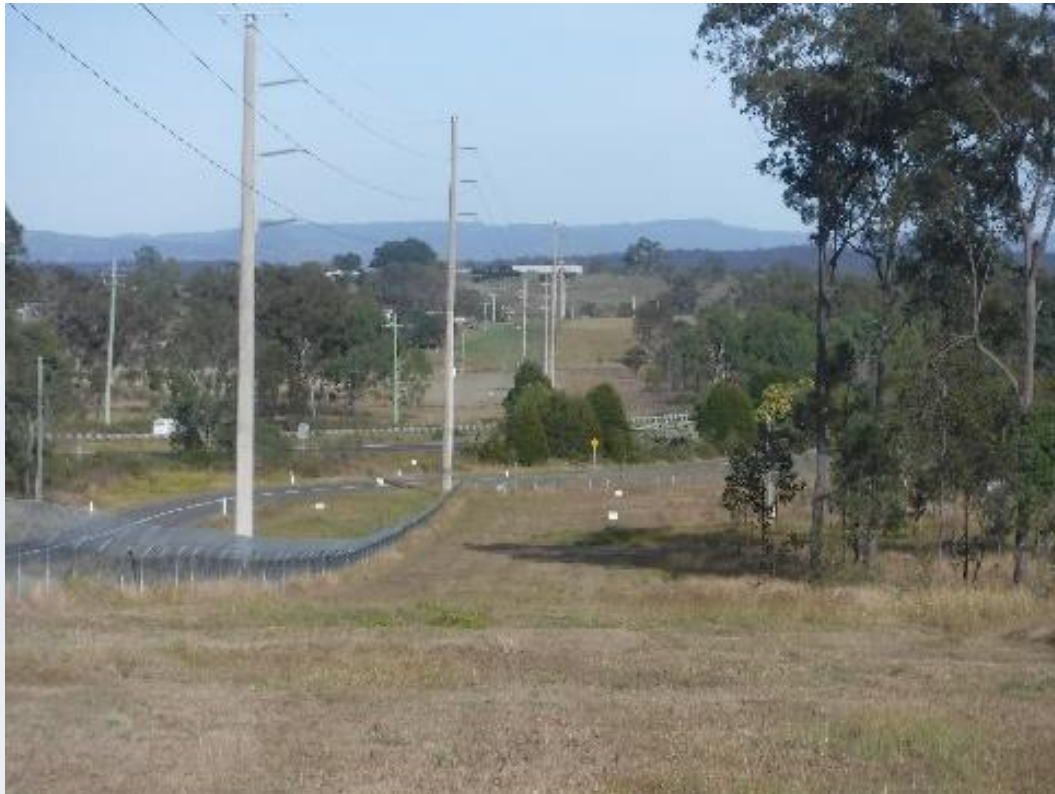
I (localised flooding and therefore temporarily inaccessible to machinery) a ten-metre wide strip of land immediately inside and adjacent to the koala exclusion fence is regularly, and has recently been, mowed along the entire length and contains no trees or regrowth. This mowing work is arranged by the operator of the existing high underground pressure gas pipeline that is located along and inside the southern boundary of the lot. See below photograph.
