Annual site and fencing inspection report

The second bullet point in **Table 2 Offset Strategy Details** in the EPBC Approval (EPBC 2017/7994) for the Lockyer Energy Project requires the following actions to be undertaken:

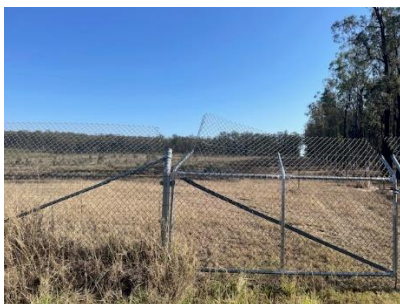
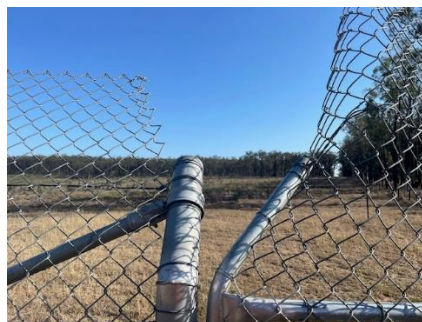
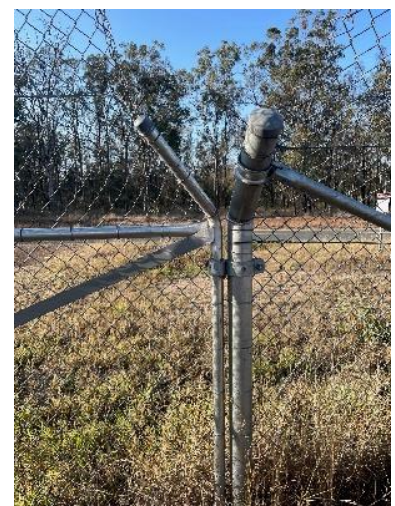
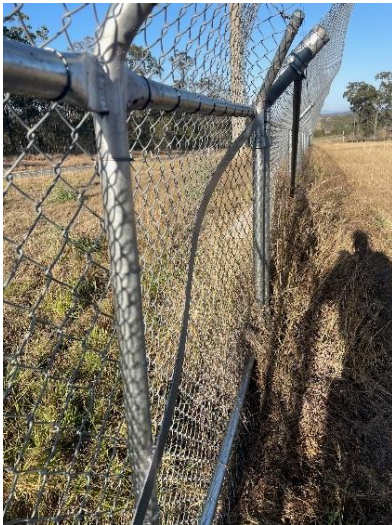
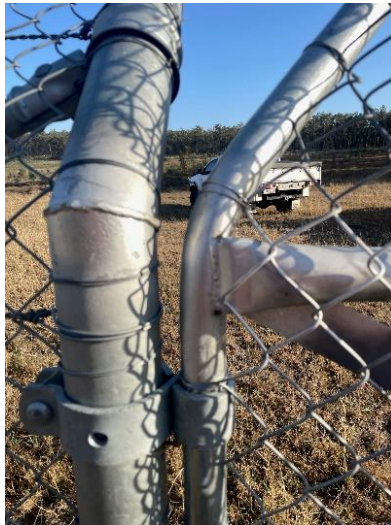
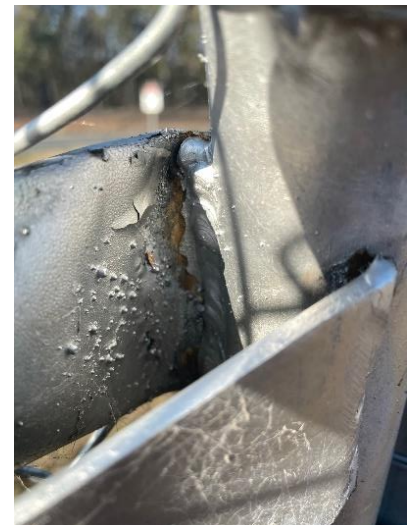
- a. The koala exclusion fence along the southern boundary of the lot, has been damaged. While most of the fence is in good condition, the left-hand gate at the south-east corner of the property has been bent and is no longer koala-proof. It appears that the gate may have been inadvertently opened in an inwards direction at some time (possibly some months ago, as indicated by visible corrosion developed in the cracks on the galvanising), causing the hinge post to press against the left hand angled stanchion and bend it in a clock-wise direction to the right about 250mm, creating a gap in the overhanging netting. See photographs below.

I will informally ask the pipeline operator to instruct their mowing contractors to only open the gates in an outward direction, to avoid any further damage.

- repair the three damaged fence items including the front gate before the Annual Compliance Audit Report
- mow the 10m wide fence maintenance line along the western, northern and eastern boundaries before the Annual Compliance Audit Report
- apply herbicide to control regrowth within the cleared project footprint before the Annual Compliance Audit Report.

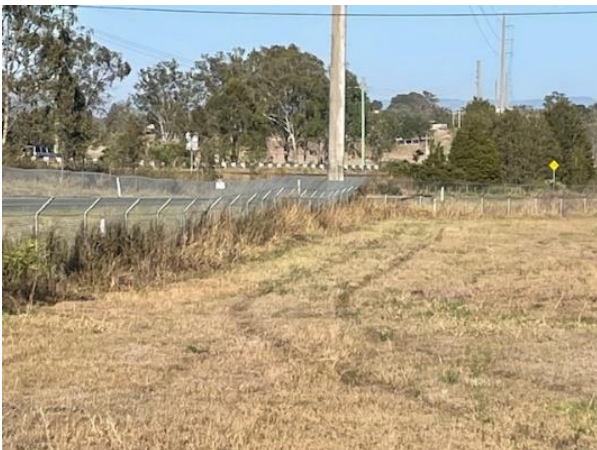
- b. The property accommodates a buried high-pressure gas pipeline, and the pipeline operator maintains vegetation to its own standards, namely a 10 m wide (as opposed to the requirement in the EPBC Approval for a minimum of three metre wide) strip of mown grass (immediately inside and adjacent to the koala exclusion fence) with no woody weeds or trees. Coincidentally, the pipeline easement abuts the southern boundary of the lot. See below photograph.

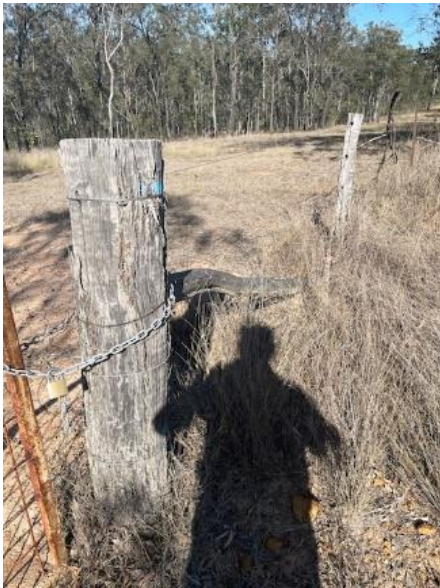
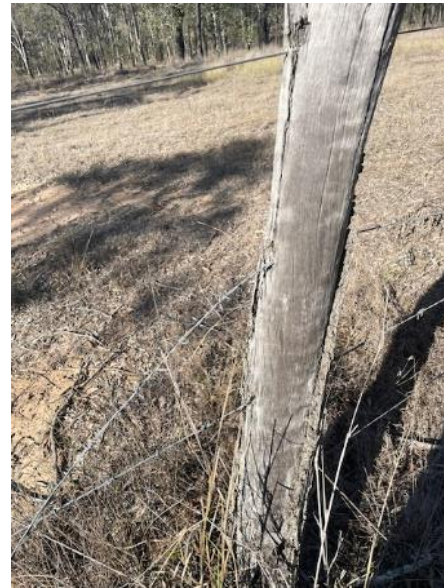
- c. As no project infrastructure has yet been installed, there is no other koala exclusion fencing present.
- d. The wildlife friendly fences along the western, northern and eastern sides of the lot are in generally good condition. They include a plain top wire, a plain bottom wire, and variously two or three middle wires which are ordinary barbed wire.
- e. One barbed-wire adjacent to the north-eastern gate on Rangers Road is broken and must be restored (see photographs below).

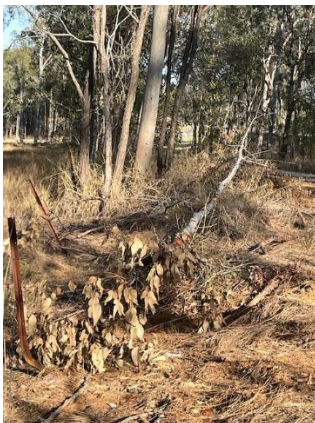
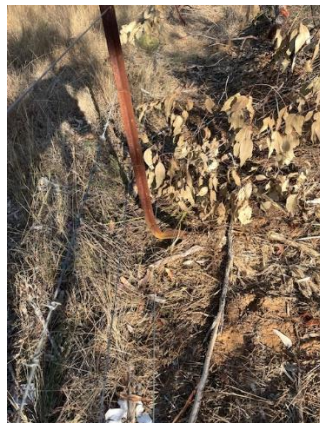
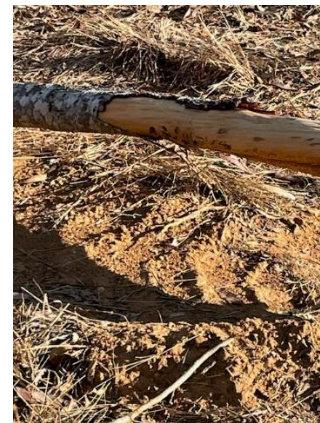
- f. Two star-steel fence posts along the northern boundary fence have been damaged some time ago by heavy machinery (wheel tracks persist) working within Ranger Road, are bent and must be replaced (see photographs below).

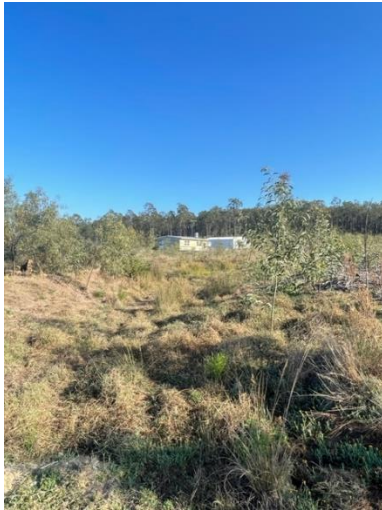
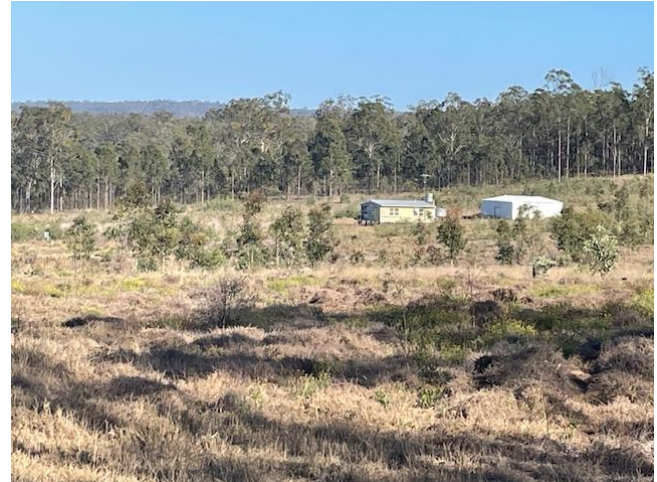
- g. The fence maintenance lines along the western, northern and eastern boundaries contain long grass which will require slashing. Very few weeds (and only a few isolated lantana plants) were observed along these fences, which indicates that weed control work conducted in 2022 has been effective.
- h. The area which was cleared of trees in September 2021 (the approved project footprint) contains a number (a few hundreds) of eucalyptus regrowth suckers, up to 4 m tall (see photographs below).

- i. Left untreated there is a risk that this area will revegetate by itself within a short period, thereby requiring repetition of some of the approved clearing work that was performed in 2021. I inspected the area with Graeme Jenkins of Leading Rural Traders on the 2nd of October, and he is available and willing to treat all those suckers by a further hand-spray application of a suitable herbicide within October 2023. Graeme advised me that he must use hand-spray techniques as the presence of many felled tree trunks across the area precludes the use of a truck-mounted boom spray.

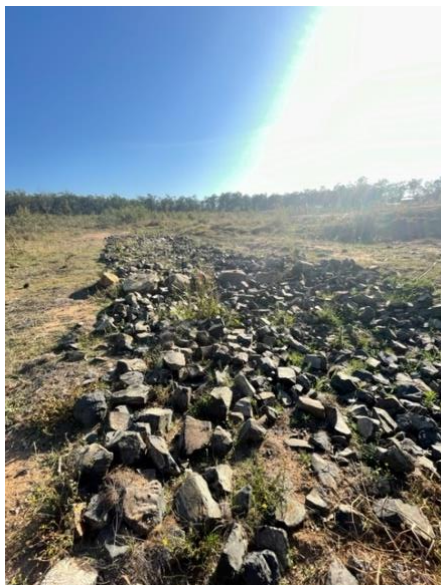
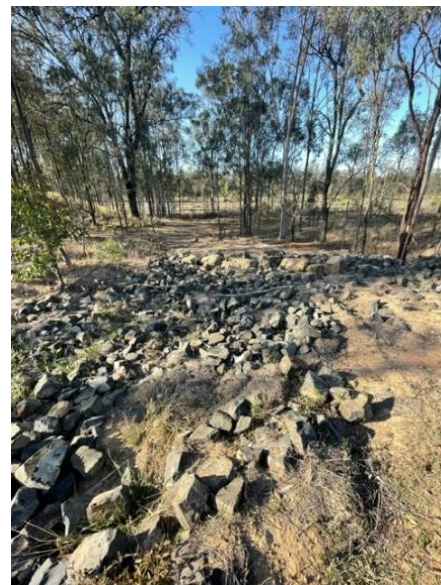
- j. The by-wash located on the north-western and western side of the farm dam (located in the southern end of the cleared area) previously showed evidence of erosion and was repaired in 2022 by the application of suitable rock armouring. This work successfully repaired the existing erosion and has been effective in preventing any further erosion. No further action is required (see below photographs).
