# Six-Monthly site and fencing inspection report

The second bullet point in Table 2 Offset Strategy Details in Attachment B of the EPBC Approval (EPBC 2017/7994) for the Lockyer Energy Project requires the following actions to be undertaken:

On 8<sup>th</sup> June 2024 I inspected all sections of all fencing around the boundary of Lot 191 CSH2361 and advise that:

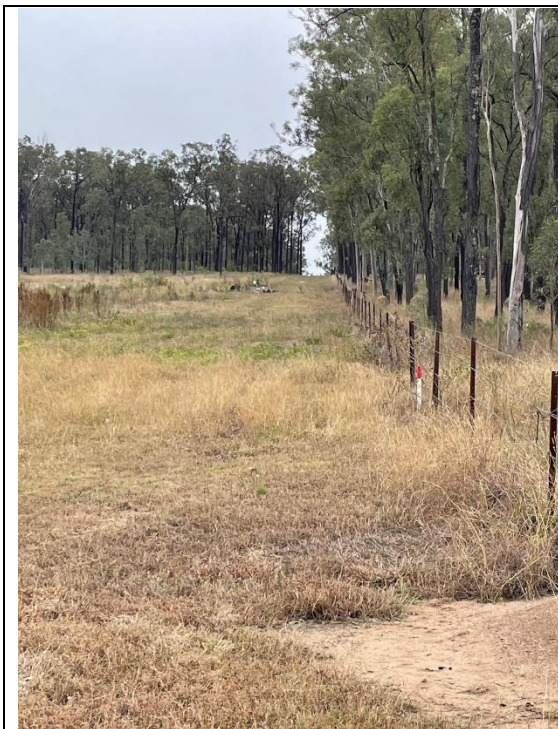
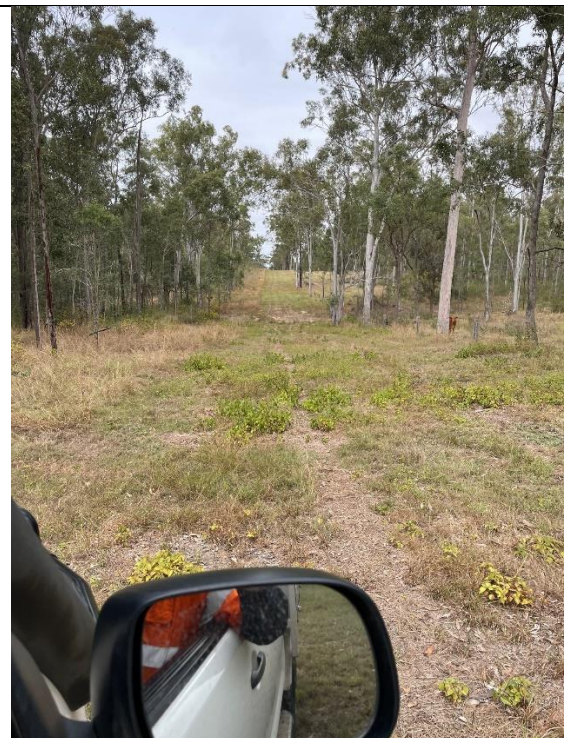
- f. The fence maintenance lines along the western, northern and eastern boundaries were mowed some weeks ago and are all in good condition. See photographs below,

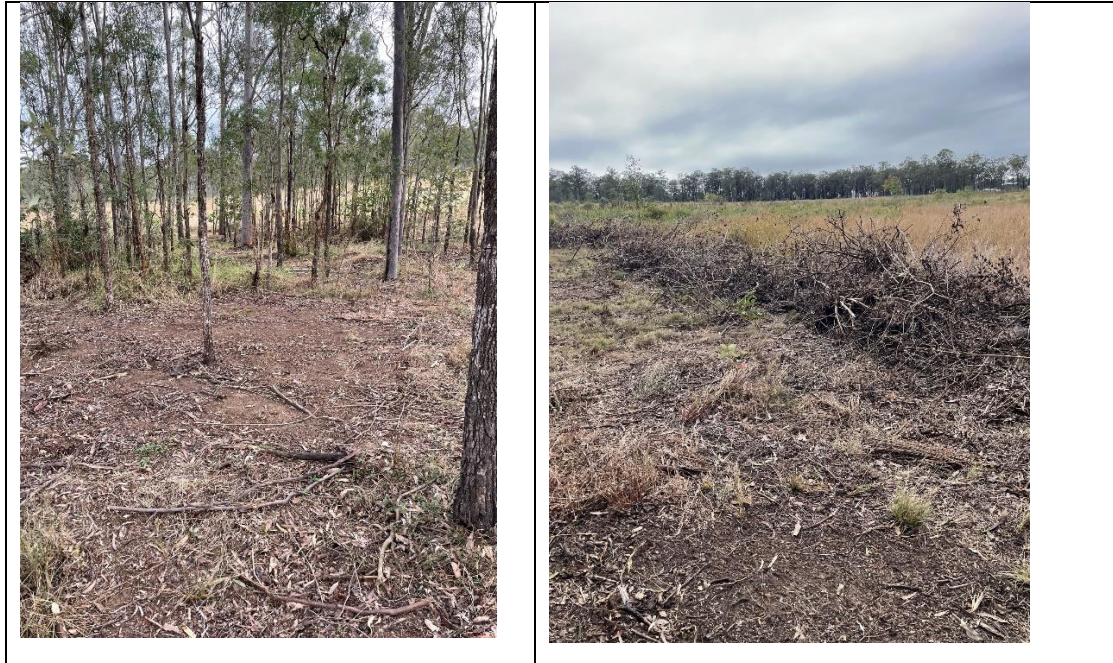
- g. One area of preserved mature vegetation (located to the west of the farm dam and south-west of the old house previously contained a large and tall (> 2 m> outbreak of Lantana). This area has been

successfully treated, by severing and removing the lantana plants, and applying a basal chemical treatment to the lantana stumps. See photographs below:

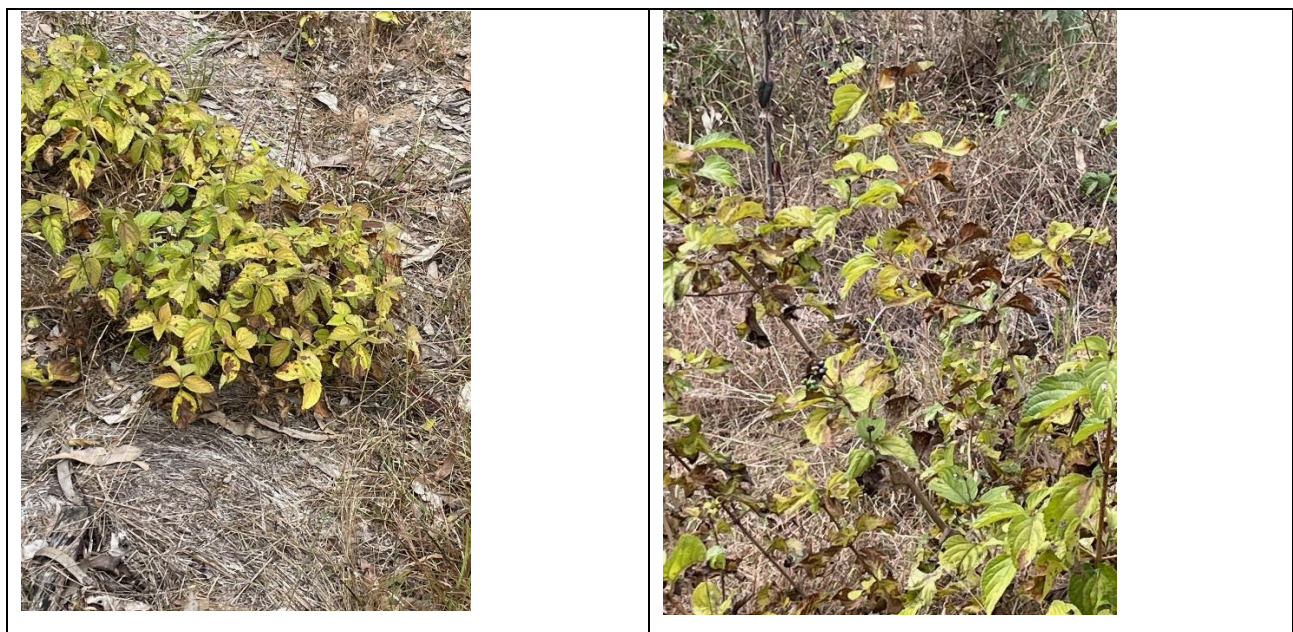
- h. Small lantana clumps inside and along the western and northern margins of Offset Area B, as well as along the southern side of Rangers Road, have been sprayed recently, and good kill rates have been achieved as evidenced by black and/or yellow spotting on foliage. See photographs of dead and dying lantana below:

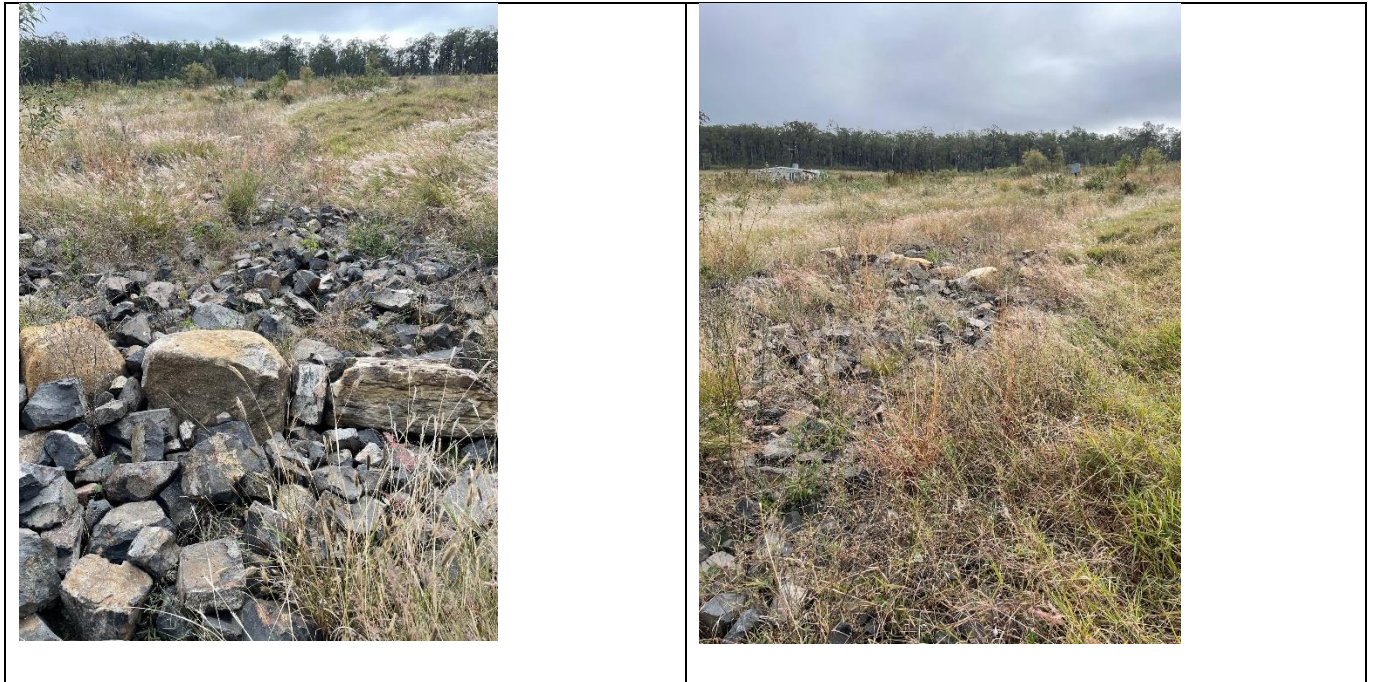
The small farm dam located in the southern end of the property is in good condition and contains ample clear water. The rock armouring that was installed to protect the by-wash/spillway is functioning satisfactorily, with no erosion present. Native grasses and herbs have begun to propagate across this area, further stabilising the channel. See photographs below:

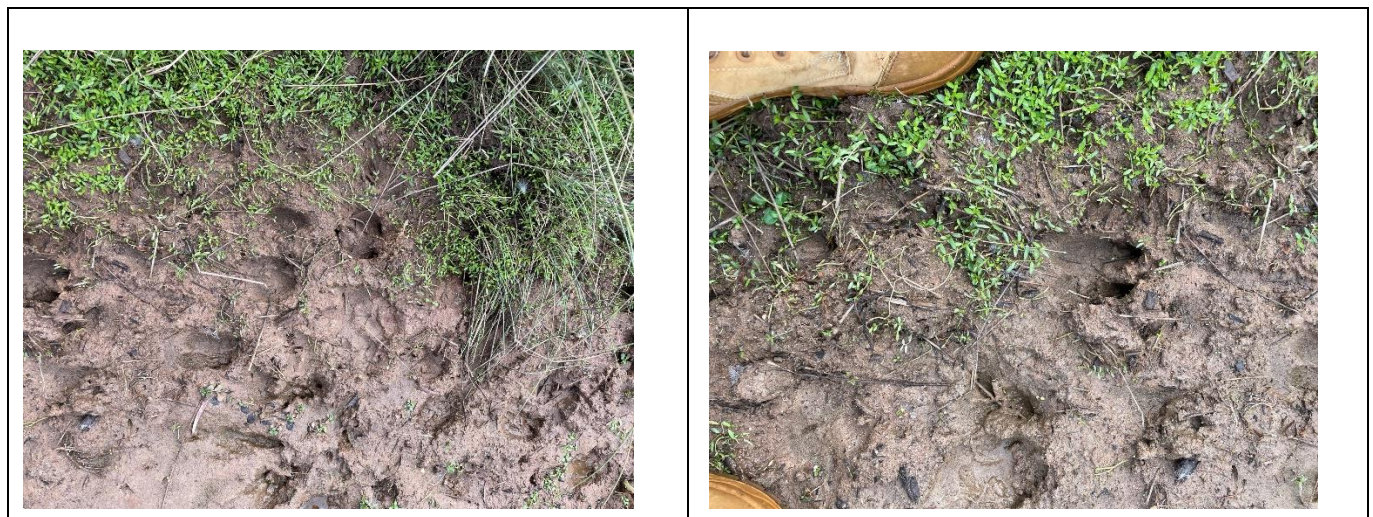
Evidence of recent (within the previous eight hours) activity by Red Deer (*Cervus elaphus*) was identified on the banks of the same dam. It suggests that at least four individuals watered at the dam. See photographs below:

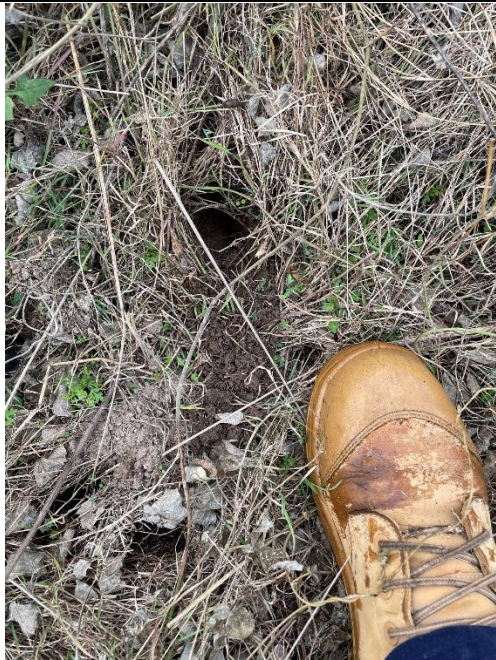
Evidence of very recent foraging activity by Bandicoot sp was identified in several locations across the site.  
See photograph below:
