Six-monthly site and fencing inspection report

The second bullet point in **Table 2 Offset Strategy Details** in the EPBC Approval (EPBC 2017/7994) for the Lockyer Energy Project requires the following actions to be undertaken:

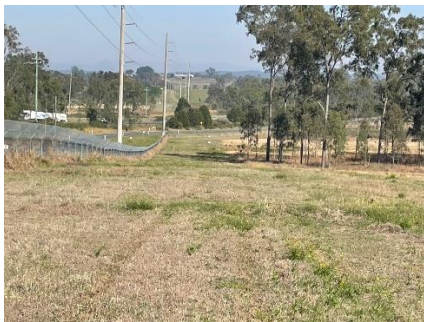
- a. The koala exclusion fence along the southern boundary of the lot is in good order, free of weeds or other live vegetation and requires no action.
- b. The property accommodates a buried high-pressure gas pipeline, and the pipeline operator maintains vegetation to its own standards, namely a 10 m wide (as opposed to the requirement in the EPBC Approval for a minimum of three metre wide) strip of mown grass (immediately inside and adjacent to the koala exclusion fence) with no woody weeds or trees. Coincidentally, the pipeline easement abuts the southern boundary of the lot. This easement has recently been mowed, is in good condition, and requires no action. See photograph below:

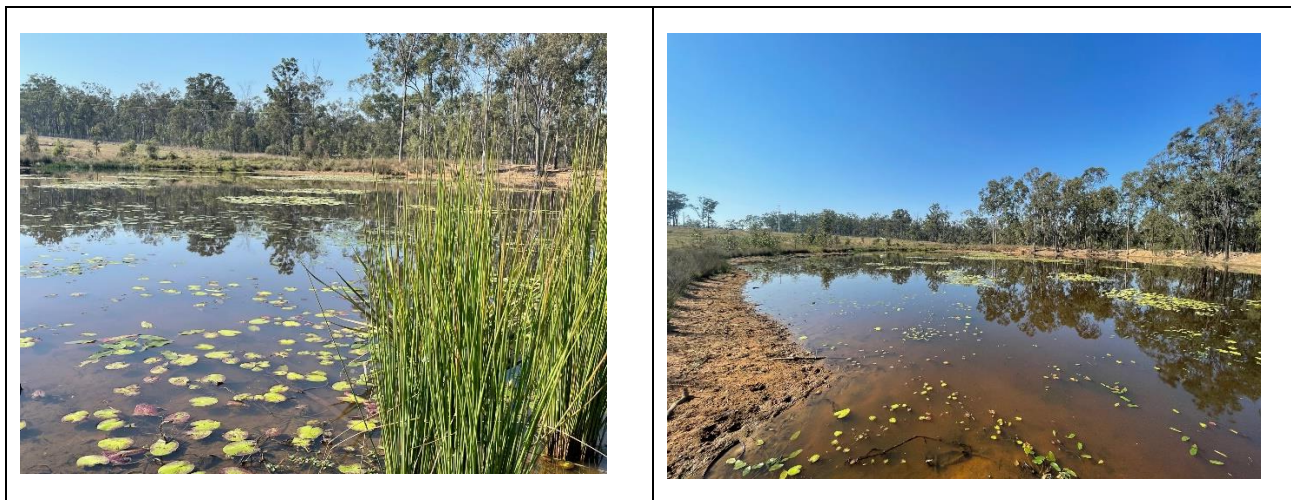
- c. As no project infrastructure has yet been installed, there is no other koala exclusion fencing present.
- d. The farm dam situated in the southern end of the property is full of water, and now contains a number of water reeds and other aquatic plants. See photographs below:

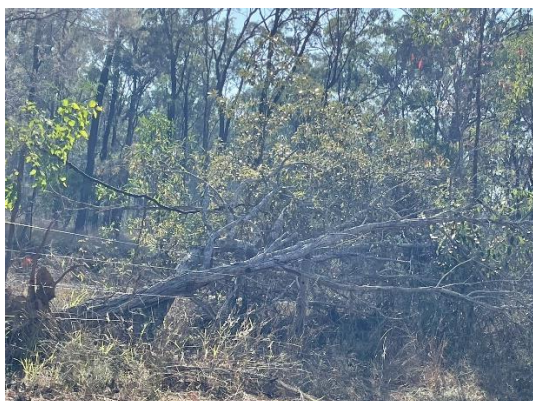
- e. The wildlife friendly fences along the western, northern and eastern sides of the lot are in generally good condition. They include a plain top wire, a plain bottom wire, and variously two or three middle wires which are ordinary barbed wire.
- f. A tree has fallen onto the northern fence and will require to be cut up with a chain-saw, the branches removed and the wires re-tensioned. (see photograph below).

- Remove the fallen tree across the northern boundary fence and re-tension the fence
- Selectively spot-spray lantana weeds within the western margin of the vegetation offset area.

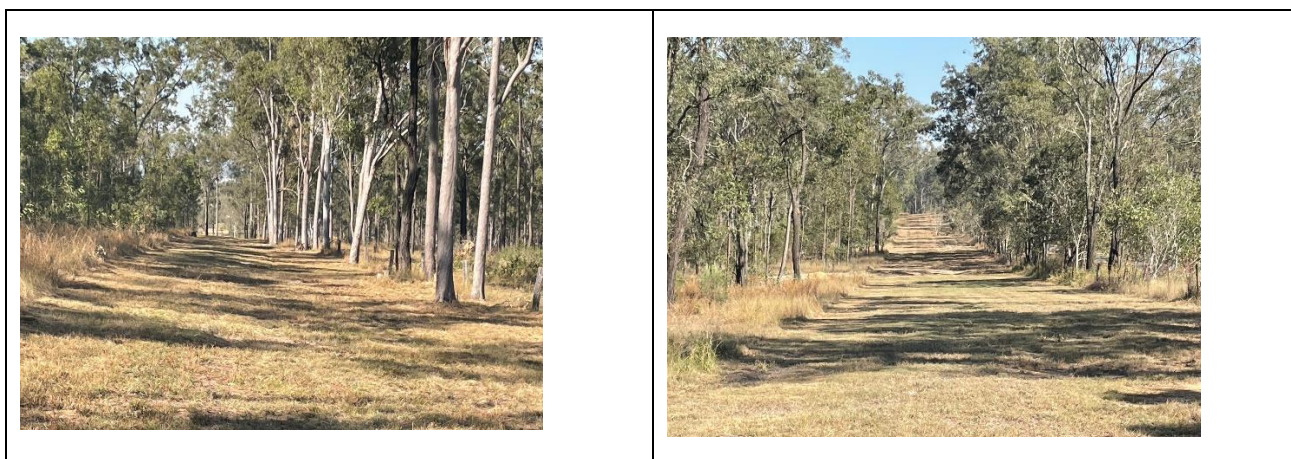
- g. The full length of each of the fence maintenance lines along the western, northern and eastern boundaries were mowed by a contractor using a tractor-mounted slasher in the week commencing 2 September 2024, are now in good condition, and require no action. (see photographs below)

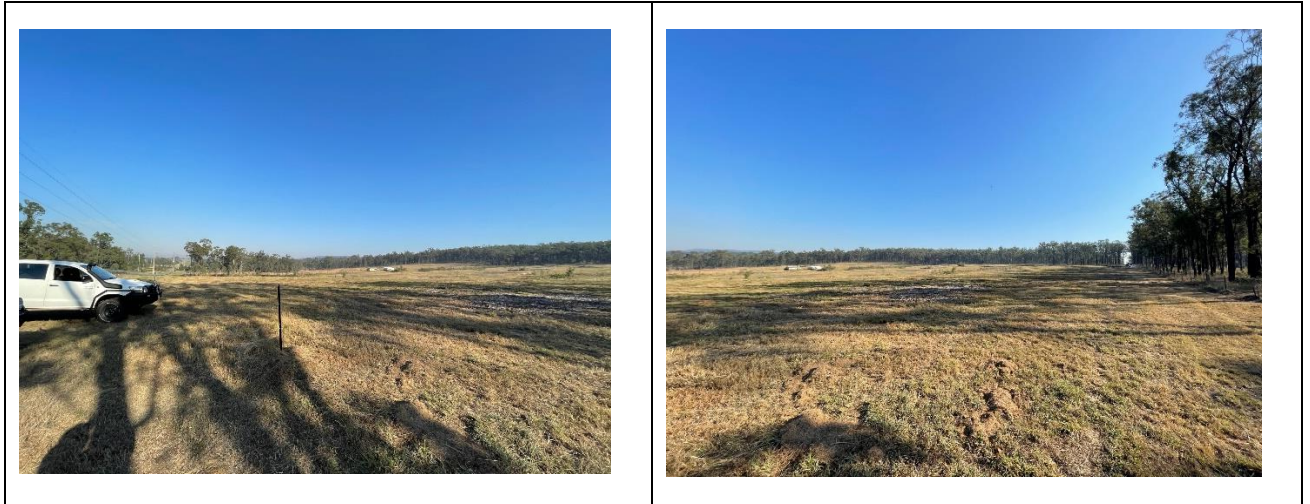
- h. The area which was cleared of trees in September 2021 (the approved project footprint) contained several hundred eucalyptus regrowth suckers, up to 2 m tall, plus areas of woody weeds. This whole area was mowed by a contractor using a tractor-mounted slasher in the week commencing 2 September 2024. The area is now in good condition and requires no action (see photographs below).

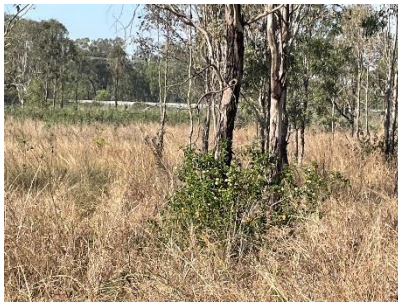
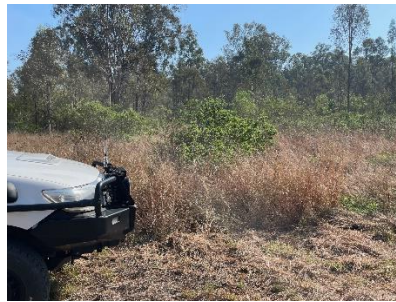
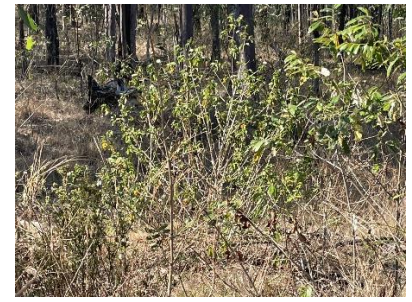
- i. A few hundred lantana weeds have emerged along and inside the western boundary of the vegetation offset area. These weeds require spot-treatment using a suitable herbicide, delivered via long, hand-held, hoses/nozzles, to avoid moving vehicles into that area and damaging other vegetation. (see photographs below)
