04 November 2024

Follow-up Inspection of Lockyer Power Project Site

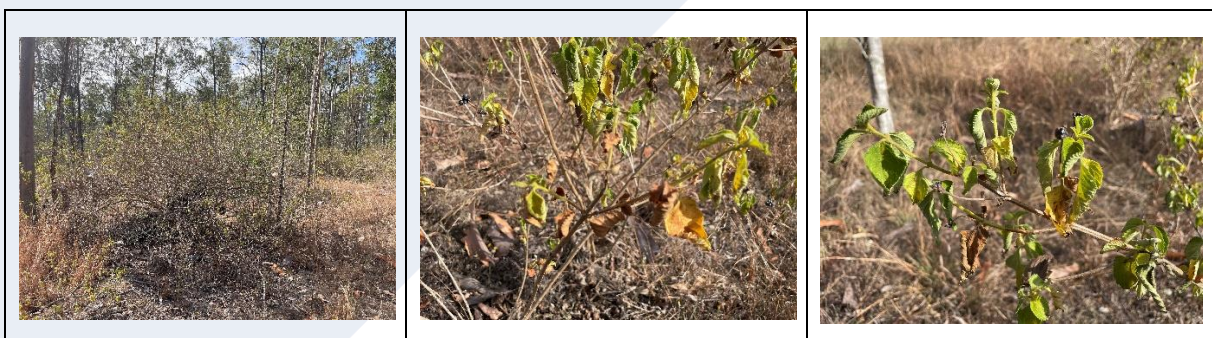
1. The fallen tree has now been removed from the northern property boundary fence and the fence has been properly reinstated.
2. All areas of lantana regrowth which were identified in the **2024 Flora and Weed Audit Report** have been treated by hand-spraying of herbicide. See below photographs for evidence of dead and dying lantana plants.

All of the above work was completed by ProEarthworks before the end of October 2024.
