21 November 2023
File Ref: S522202EL002_v1.0
Contact: Rob Siddle

**2023 ANNUAL NATIVE VEGETATION AND WEED COMPLIANCE AUDIT AND 5 YEAR MILESTONE REPORTING
LOCKYER ENERGY PROJECT, 2.5KM NORTH OF GATTON, QUEENSLAND (EPBC 2017/7994)**

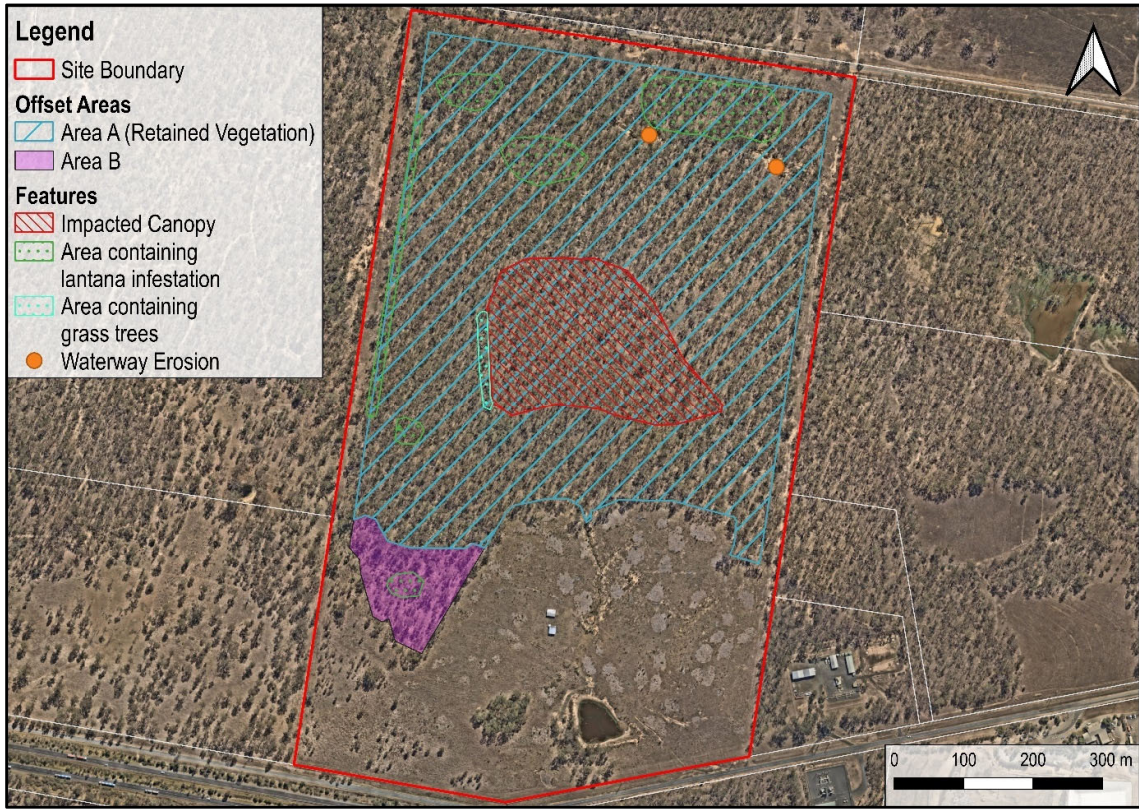
Figure 2. Approximate Location of Previously Impacted Vegetation (poor health/dead and regenerating) within the Retained Vegetation and other site features within the Offset Areas.

- An area of poor health and dead standing timber was again observed in the approximate centre of Offset Area A (refer **Figure 2**) as identified in the previous annual inspection undertaken by S5 Environmental in 2022 (S522202EL001v1.3 dated 26 October 2022). It is noted that this area being situated on a ridgeline, is the most elevated and exposed part of the site. It is considered that this occurrence may have been the result of storm activities, past agricultural practices, or the like. It is noted that there has been regrowth on some of the impacted canopy trees and there is natural regeneration of eucalyptus and wattle species, in particular. It is recommended that this area continues to be monitored annually to determine if regrowth or improved health continues to occur over the next 12 to 24 months.

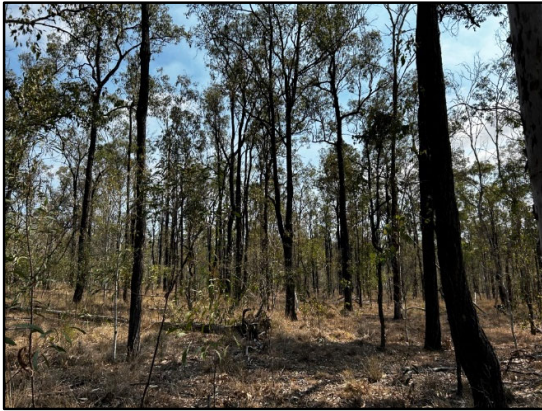
Plate 1: Photograph of the woodland vegetation through the eastern extent of Offset Area A.

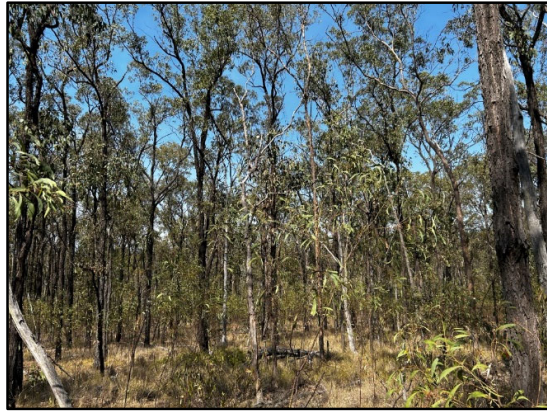
Plate 2: Photograph of the woodland vegetation through the southern extent of Offset Area A.

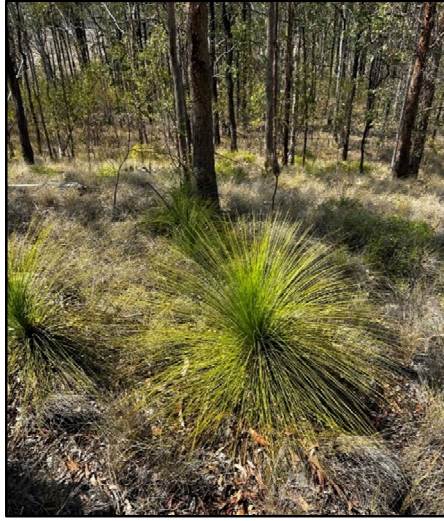
Plate 3: Scattered regenerating grass trees (*Xanthorrhoea*) on the western slope of the ridgeline through Offset Area A.

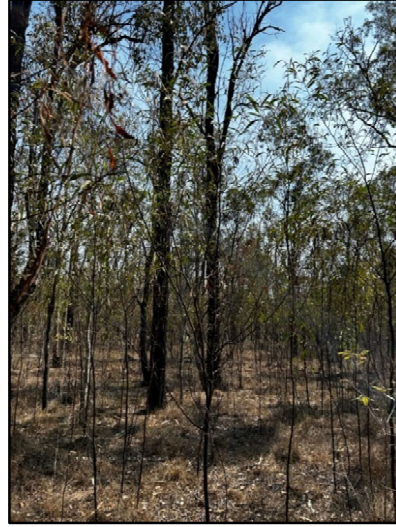
Plate 4: Regrowth through the eastern portion of Offset Area A.

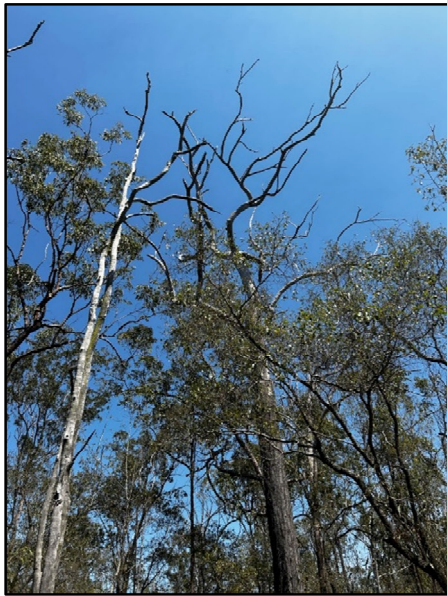
Plate 5: Dead trees in the northern portion of the Impacted Area in Offset Area A.

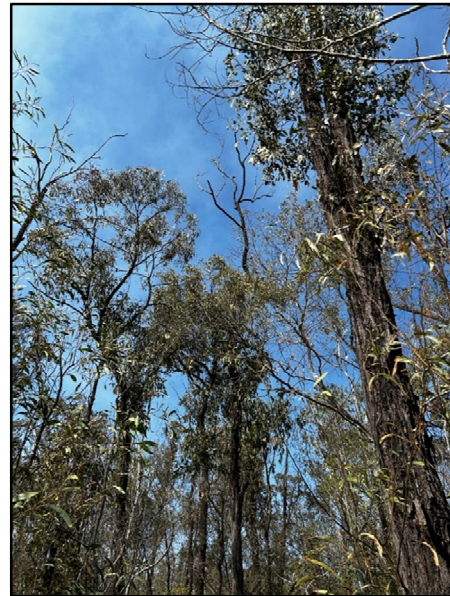
Plate 6: Regenerating canopy trees through the centre of Offset Area A.

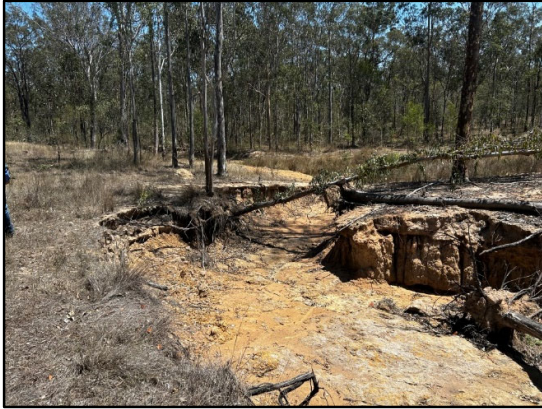
Plate 7: Area of erosion on eastern extent of the waterway through the north of Offset Area A.

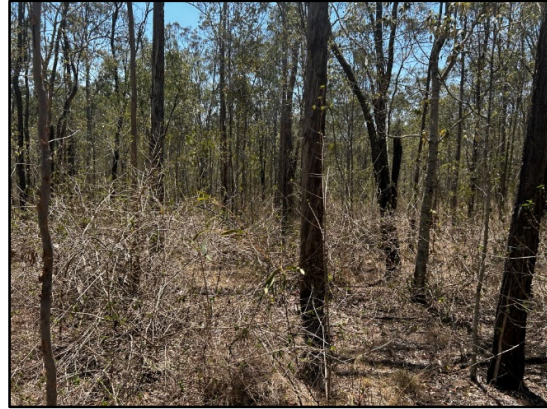
Plate 8: Lantana infestation in north-western portion of Offset Area A (south of the waterway).

- It is understood that weed maintenance has been undertaken to control lantana. Lantana observed appeared to be dead or in poor condition with heavy defoliation, which is likely due to herbicide application, dry conditions, or both. Ongoing weed maintenance is to be undertaken to specifically control lantana, but also any other weeds observed. The success of this ongoing maintenance is to be monitored, should weeds become more prevalent, then it is recommended maintenance events are increased;

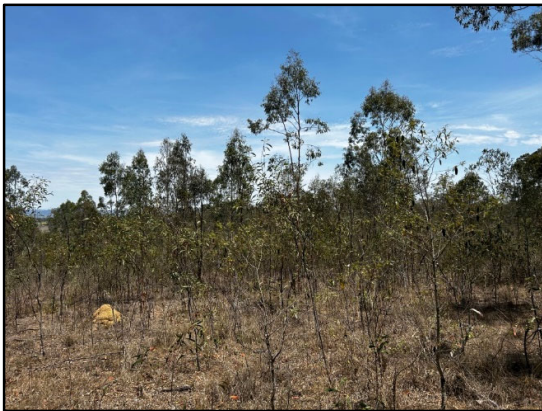
Plate 9: View through Offset Area B to the south-west. Regrowth wattle and emergent canopy.

- Natural regeneration is occurring within Offset Area B and should be monitored over time. Assuming improved growth conditions, i.e. rainfall, over the next 12 months, this regeneration should continue and improve. However, should no improvement in the diversity of species be evident over the next 12 to 24 months, infill planting of tube stock may be required to ensure target densities are met. Refer Table 1 on LRP06 of the Litoria Landscape & Revegetation Plan (Ref:

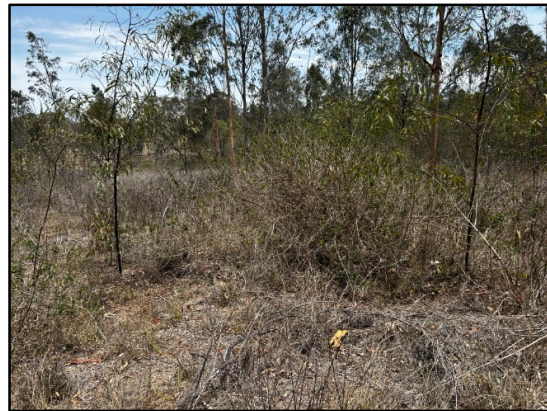
Plate 10: Lantana in the central portion of Offset Area B.
